Tailings Storage Facility Spillway Foundation Grouting

BAN HOUAYXAI
GOLD-SILVER PROJECT
Phu Bia Mining Company
Lao PDR

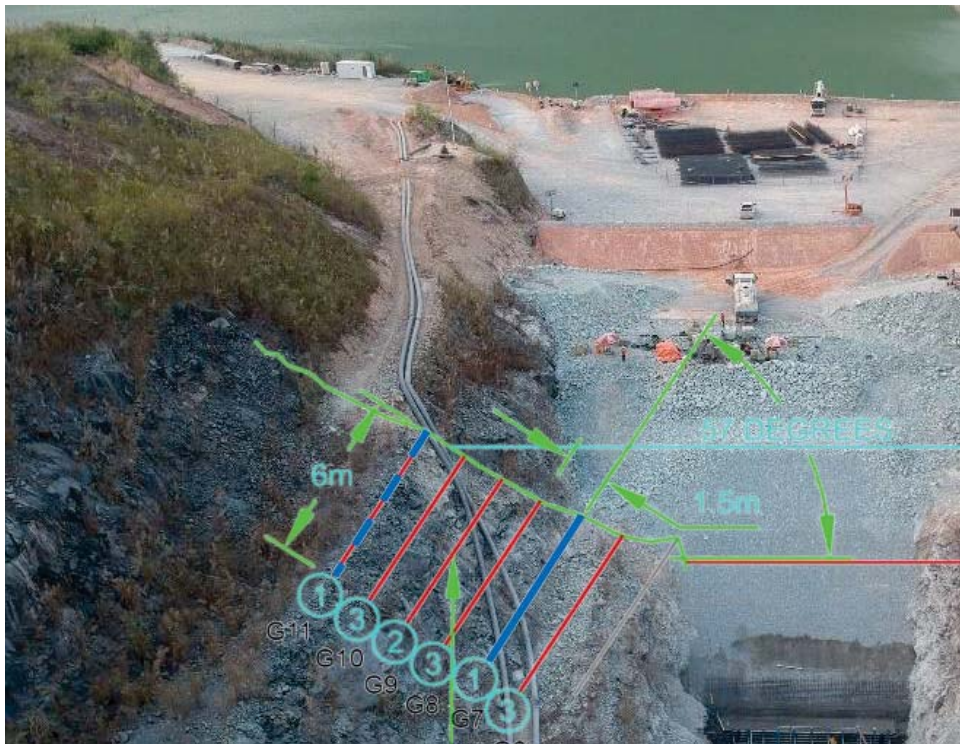
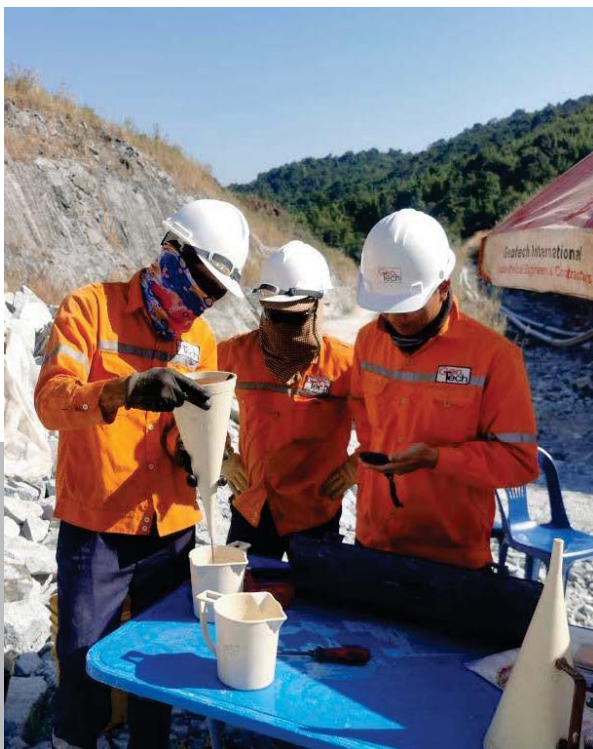
Grout trial mix performed at grouting site

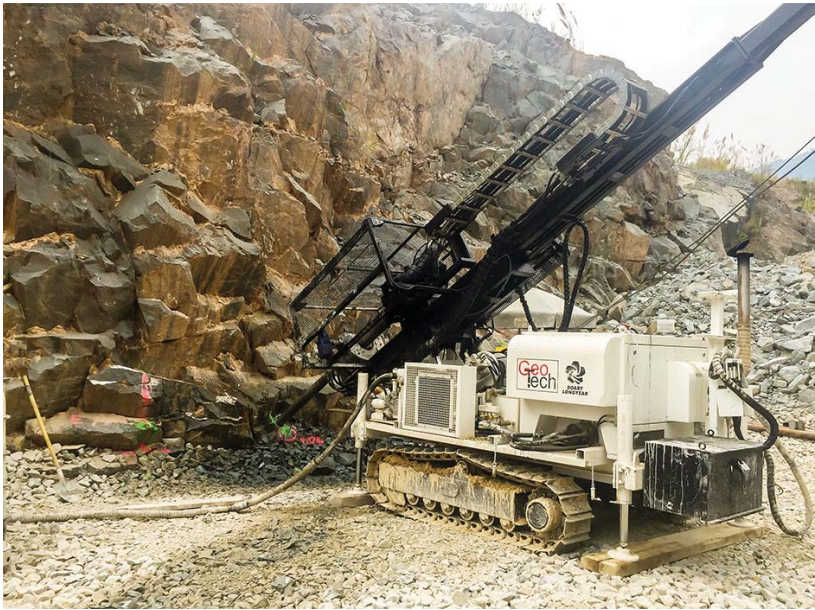
Boart Longyear drilling equipment used to perform the drilling work at grout hole of the BHX TSF Spillway – Lao PDR

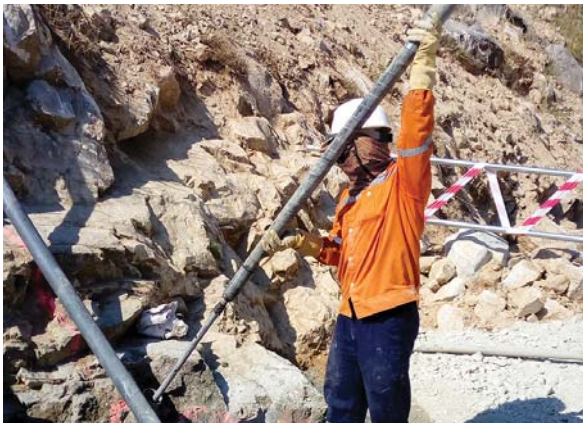
Installation of packer/grout equipment at grout hole on the right abutment of the BHX TSF Spillway

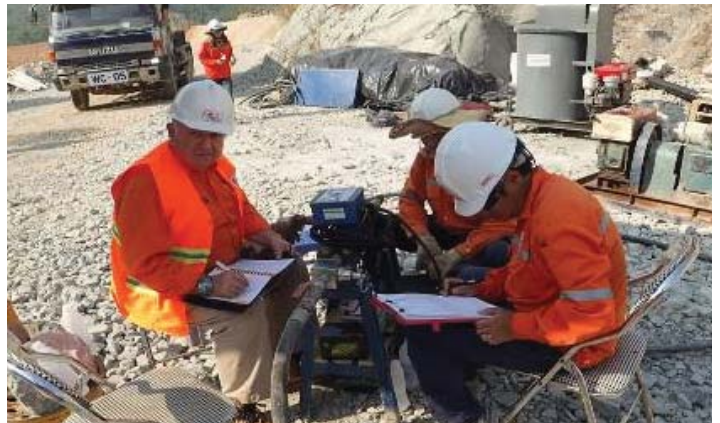
Grout injection in progress performed using DAT instrument readout at the BHX TSF Spillway - Lao PDR

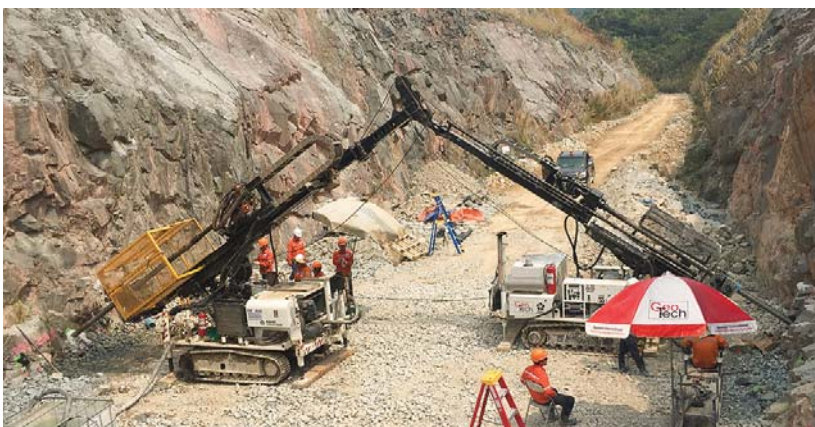
Drilling and Grouting Operation at BHX TSF Spillway – Lao PDR
